Diagnostic Testing For the Determination of Quality of Live-Line Ropes

D. P. Wichmann,
Royal Australian Navy
Australia

T. K. Saha,
University of Queensland
Australia

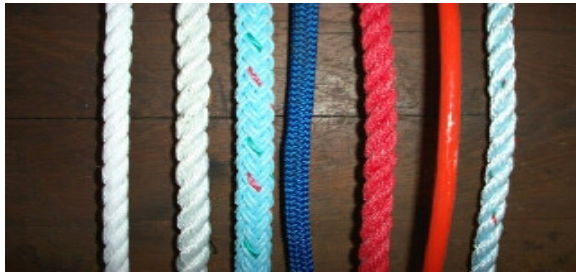
Figure 1 – Rope Specimens

High Density 3-Strand Polypropylene	<i>Sample A</i>
3-Strand Polydacron	<i>Sample B</i>
9/16 Polytron	<i>Sample C</i>
Nylon Static 11mm	<i>Sample D</i>
Waxed Polyethylene 3-Strand	<i>Sample E</i>
Shielded Kevlar Stringing Cable	<i>Sample F</i>
3-Strand Polydacron Cord	<i>Sample G</i>

Figure 1 illustrates the seven specimens listed in Table 1 with Sample A on the left through Sample G on the right.

A B C D E F G

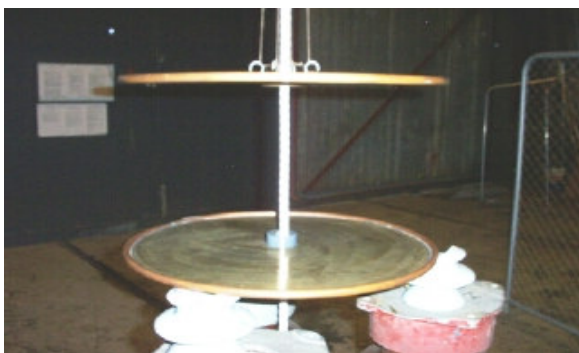
Figure 2 – AC Leakage Current Test Arrangement

Rope samples of 8 ft in length were suspended vertically and kept taut with a 10lb weight. Electrodes designed to shield the majority of stray capacitances were separated by 1ft (305mm) [1]. The brass plates have a diameter of 500mm and have copper tubing of diameter 12mm silver soldered around the circumference of the brass plates to prevent any edge discharge. Holes of diameter 45mm are present in the centre of each plate to allow the fixing of the electrode arrangements. The top plate is energized at high potential hence a brass nut of diameter 52mm and centre hole of 8.2mm can be fixed to enable attachment to the sample. The lower plate is insulated from the sample with a nylon insulating support of diameter 52mm. This support has a brass insert to provide the electrical connection to the sample. A separate brass lug is soldered onto the outside face of the lower plate to provide an earth connection. Figure 2 illustrates the described test arrangement. After each sample had been placed in the test cell, plates were checked for distance of separation and levelness.

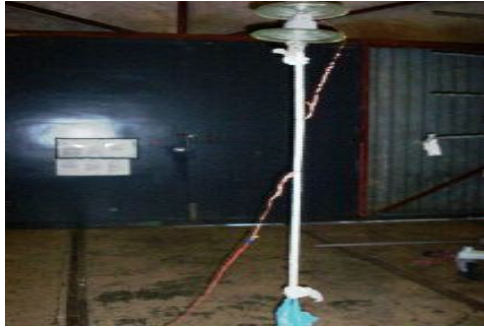
Figure 4– Dielectric Breakdown Voltage Set-up

Once this base line had been established, all specimens were tested three times at each electrode separation distance with the average recorded for analysis. Figure 4 shows the apparatus setup for the dielectric breakdown voltage test.

The specimens were suspended from a crane and held taut with the same 10lb weight. Testing methods were obtained from ASTM D 149-97a [3] and ASTM D 150-95 [4].
